# Manhole Inspection Summary

Manhole # S41U\_\_013MH

Insp Date: **10/10/08 11:34 AM**

**Location** Address: **1465 key hw.**

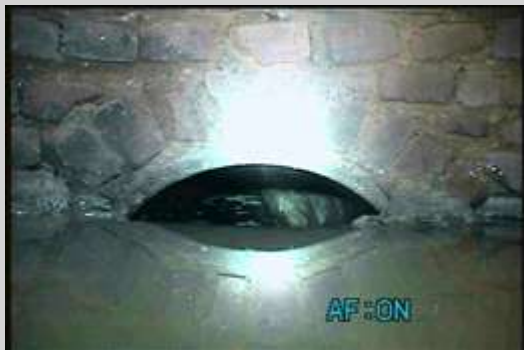
12 O'Clock Outflow

18 in. Circular Gravity Sewer  
Pipe Out @ 12 O'Clock

Infiltration: **None** Pipe Seal Cond: **Unknown**
